Justin & Mallory Fiske (Owners) 1517 Iroquois St Indian Village HDC Project Review Request Wall Replacement with Living Fence

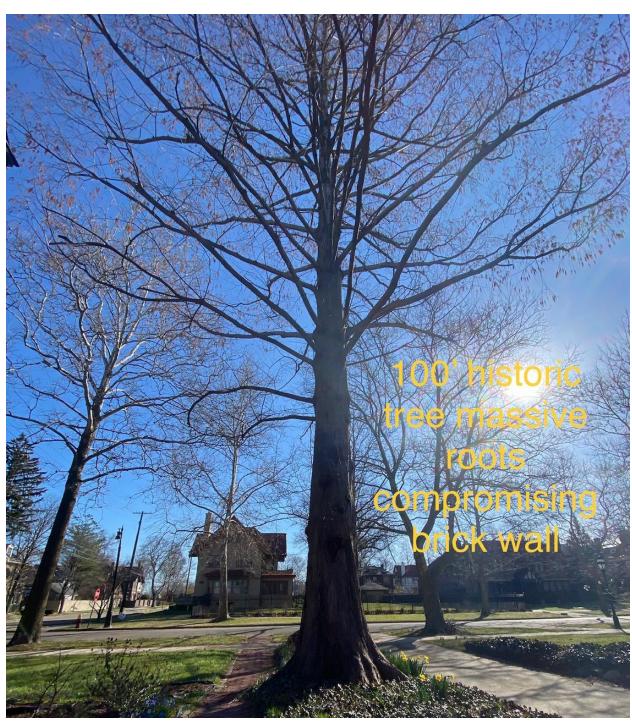
15' from tree to wall

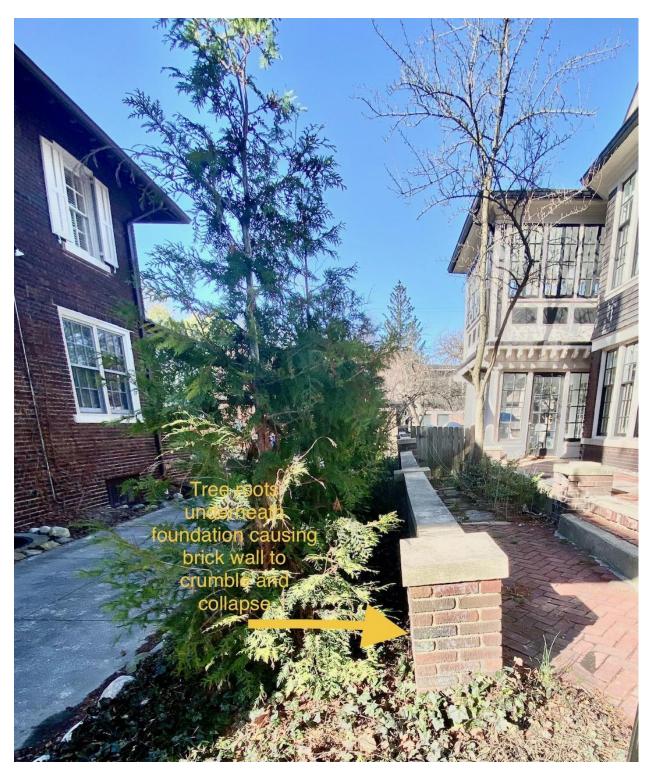
Tree line adjacent to wall

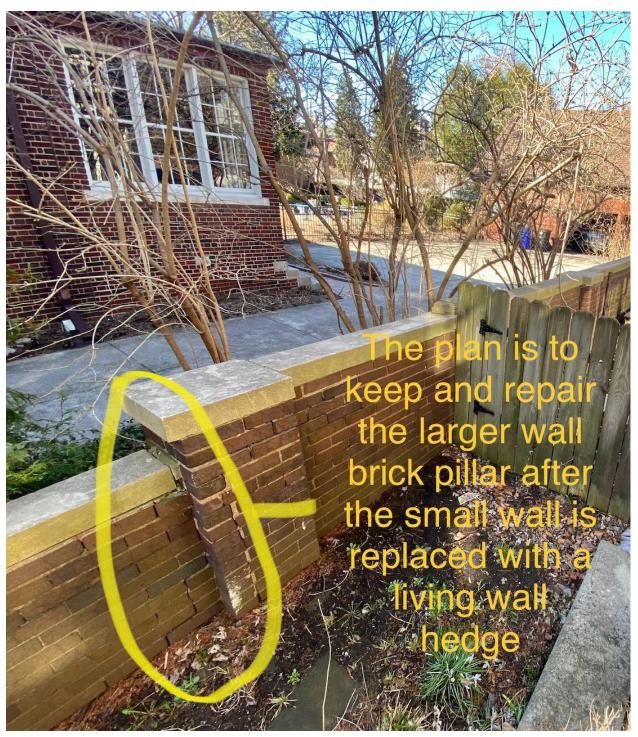
Note: The small 2.5' wall is attached to the larger wall that runs between 1517 Iroquois and 1507 Iroquois St property line. The small wall is angled at 100-110 degree angle and is bringing the larger wall down with it. If no action is done, the whole wall will come down. This plan is to avoid further damage to the larger brick wall and also preserve it. The Small wall is beyond repair with the foundation compromised.

Due to historic tree roots planted after house was built, the smaller, 29' length, 2.5' high privacy wall foundation is compromised. The small brick wall is now at a 100 degree angle; foundation lifting above surface and lifting up brick walkway. Safety concerns with small children playing near fence and the adjacent walkway. Tree roots will continue to compromise small wall. The small wall is attached to a larger 3' and subsequent 5' wall. Because the smaller wall is further leaning, it's taking down the rest of the wall with it. We are unable to replace the small brick wall unless we remove the historic 100' tree and privacy trees on the 1507 Iroquois St side of the wall.

Replace the small 2.5 foot wall with a historic living fence hedge per guidelines. We'd have to cut down the historic trees or replace the small brick wall with a living fence; otherwise a replacement small wall will inevitably suffer the same consequences with the tree roots lifting up the wall again. After the small wall and foundation is removed, the plan is to repair the 3' wall column which will become the end column, and then proceed to install the exact dimensional (29' length, 2.5' high, 1' width) living fence hedge according to HDC guidelines.

- Replace the small 2.5' high wall with a living fence hedge "Yew" based on historic guidelines.
- Repair 3' larger brick column where the small and large wall meet to preserve it from further leaning and falling over.
